January 2012 • Vol. 49 No. 1

Restoration Rescue: A CONDO CASE STUDY

By Jeff Carrier

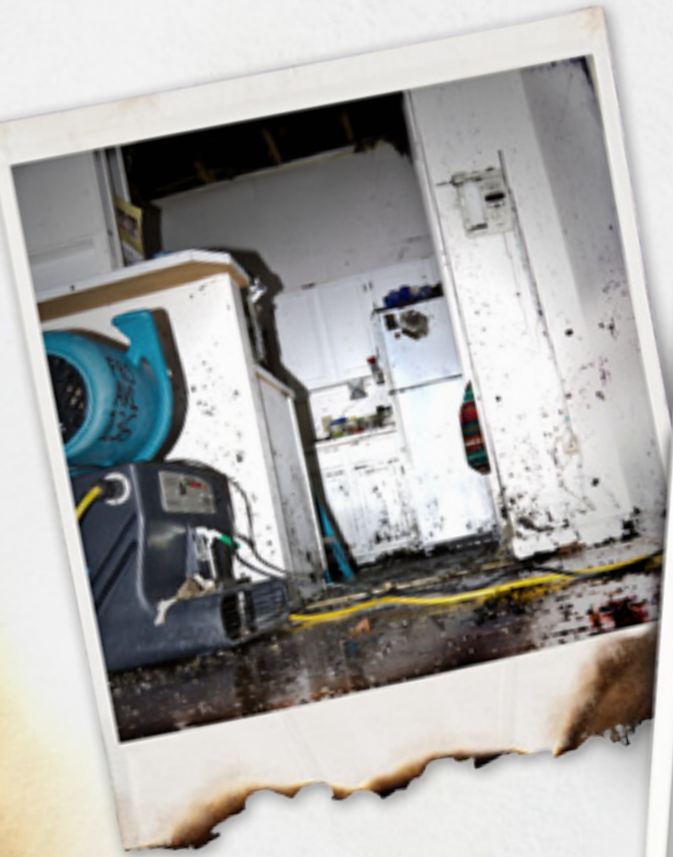
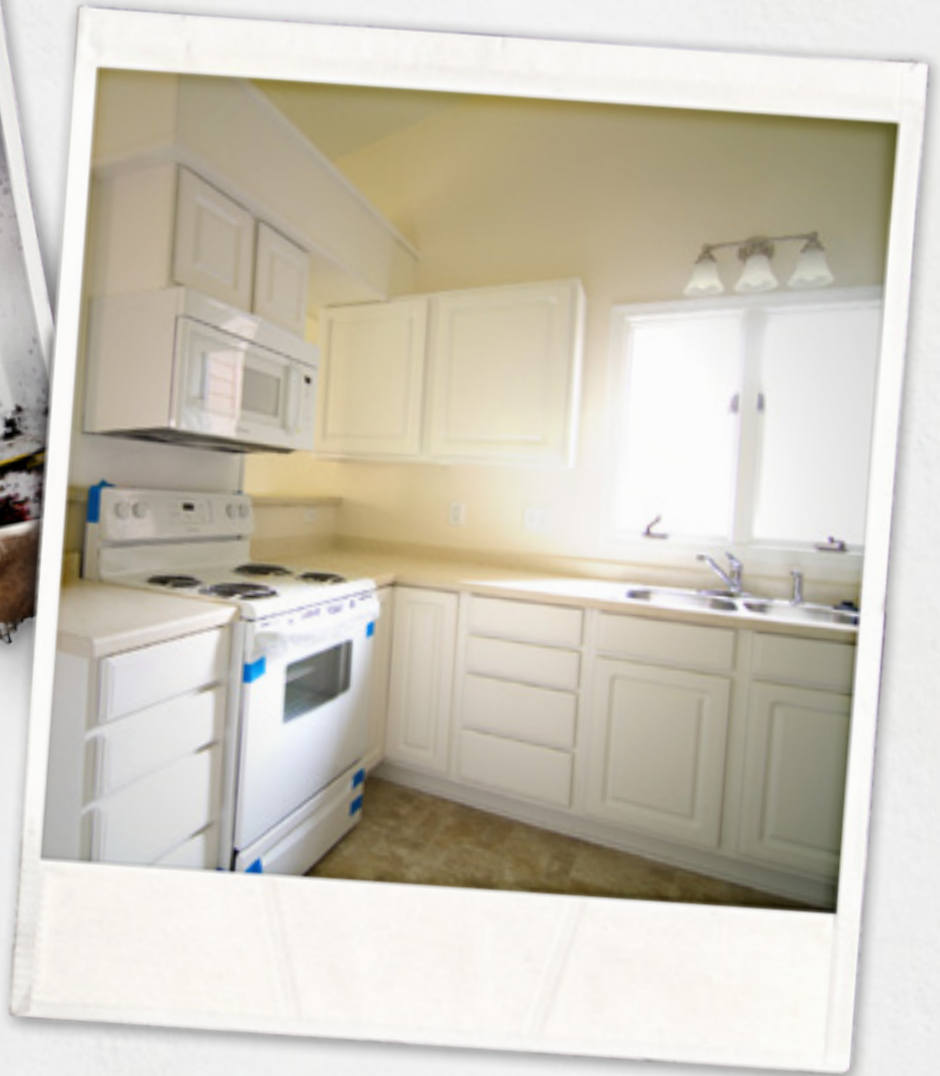
Before & After

Arriving on the scene, Gentry's team was directed to a four-unit stacked duplex. The fire started in the top right unit. This unit was severely burned in both the living room and kitchen, with smoke damage throughout the remainder of the condo. The unit below it had severe water damage in the living room and kitchen, with smoke damage throughout the remainder of the home.

The top right unit, which had the most severe fire damage, was completely gutted and cleaned down to the studs. FRS had to replace the trusses and the HVAC unit, rewire the unit and seal the studs and framing (sprayed with odor sealant). We installed new insulation, drywall, flooring, cabinets, appliances, trim, doors and lighting, as well as a new fireplace and chimney. Flooring was replaced in the top left unit; it also was repainted.
